Beaverhead Watershed Restoration Plan

December 2013

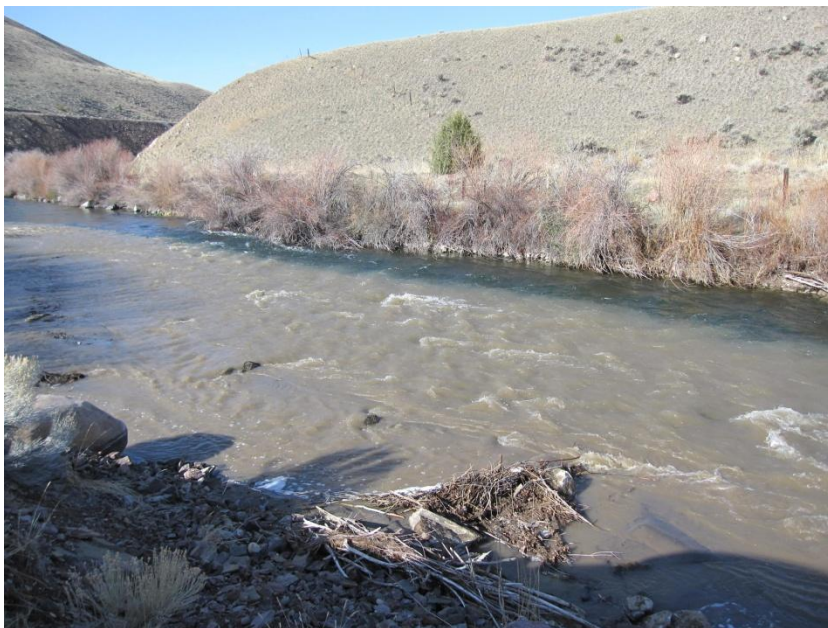
Figure 2. Sediment event from Clark Canyon Creek, 2010. Clark Canyon Creek flows into the Beaverhead on the upper left side of this photo. Note the clearer water on the far bank compared with the sediment-laden water and debris (near bank) from Clark Canyon Creek.

Periodic high sediment loading from Clark Canyon Creek has severely affected this fishery. Sediment events are stochastic (i.e., they have a random probability) and frequently result from weather events, such as rain-on-snow or severe localized thunderstorms. Conversely, average weather conditions typically do not produce harmful sediment loading. The problem is most pronounced when sediment is delivered quickly from Clark Canyon Creek at the same time as low-flow releases from Clark Canyon Reservoir and when sediment loads from the creek exceed the Beaverhead River's capacity to transport them. These sediment events create extensive deposits of fine sediment along several miles of river, resulting in a severe decline in fish abundance (**Figure 2**).

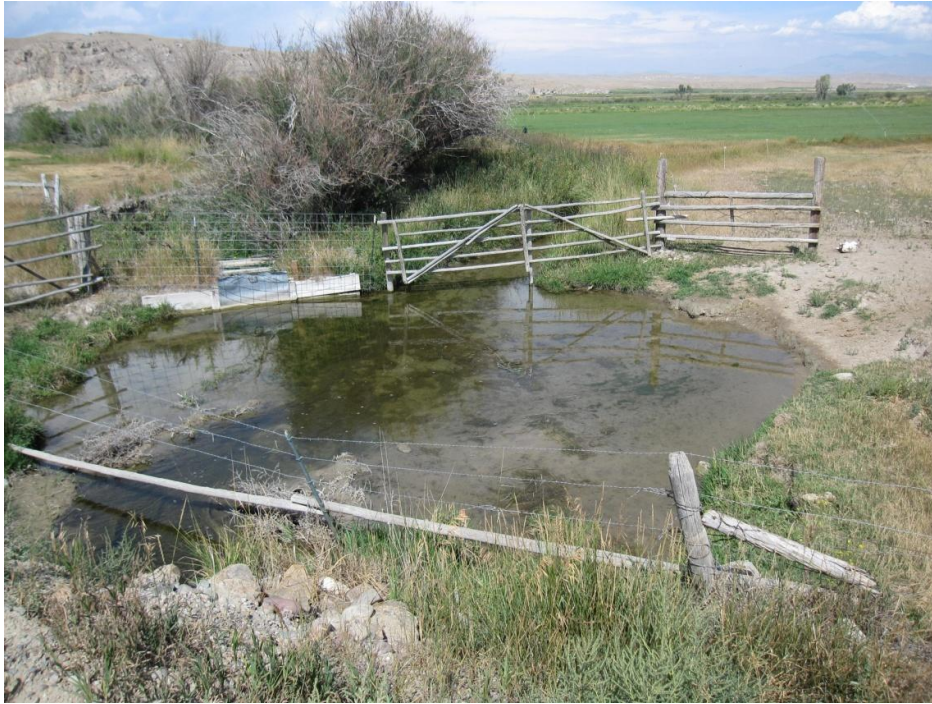
Figure 3. Lower Spring Creek. Start of the lower 0.5-mile reach just below East Bench Road. Cattle access has over-widened the channel, causing sediment deposition. The irrigation control structure is blocking the stream from fish passage. (Photo, August 2013)

- water gaps for cattle to access the stream (**Figure 3**)
- streambank and riparian restoration to reduce sediment delivery and improve fish habitat (**Figure 4**)
- floodplain access for the stream channel to prevent further head-cutting and decrease sediment to the Beaverhead River (**Figure 4**)
- improved irrigation control structures to better manage irrigation demands and allow for fish passage (**Figure 3**)
- livestock corrals at an off-stream site and a new stock watering system (**Figures 5 and 6**)
- replace a perched culvert with a new bridge to allow better fish passage (**Figure 7**)
- riparian fencing to manage grazing effects on the stream (**Figure 4**)

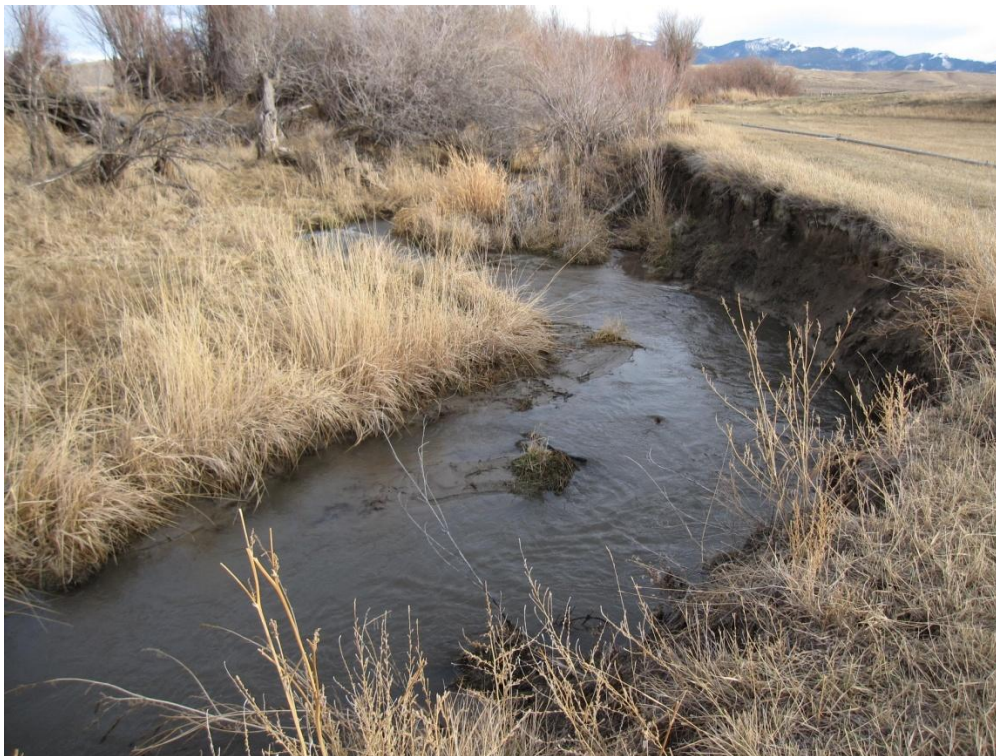
Figure 4. Lower Spring Creek. Channel banks are eroding from lack of vegetation. Riparian fencing is needed to prevent cattle access to the stream. (Photo, November 2012)

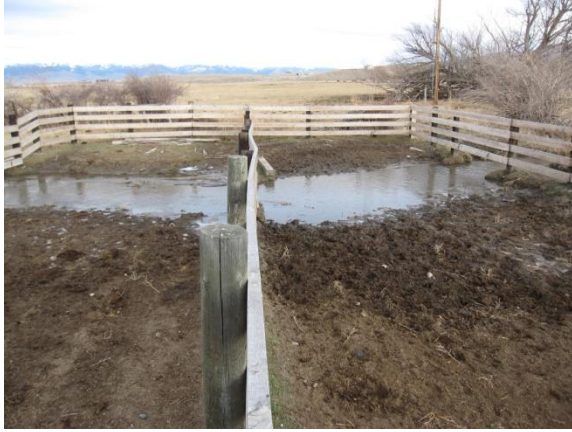
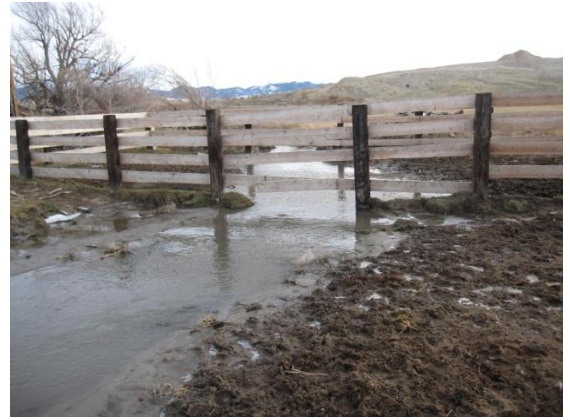
Figures 5 and 6. Lower Spring Creek. Corrals must be relocated to an off-stream site, and a new stock watering system is needed. (Photos, November 2012)

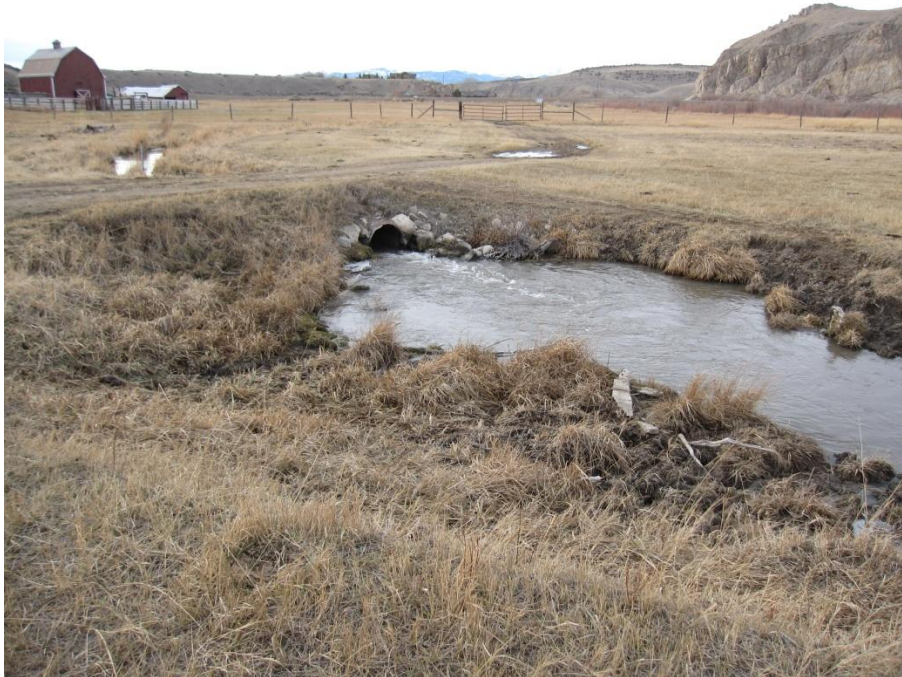
Figure 7. Lower Spring Creek. A new bridge is needed to replace the perched culvert to reduce sediment delivery and allow better fish passage. (Photo, November 2012)

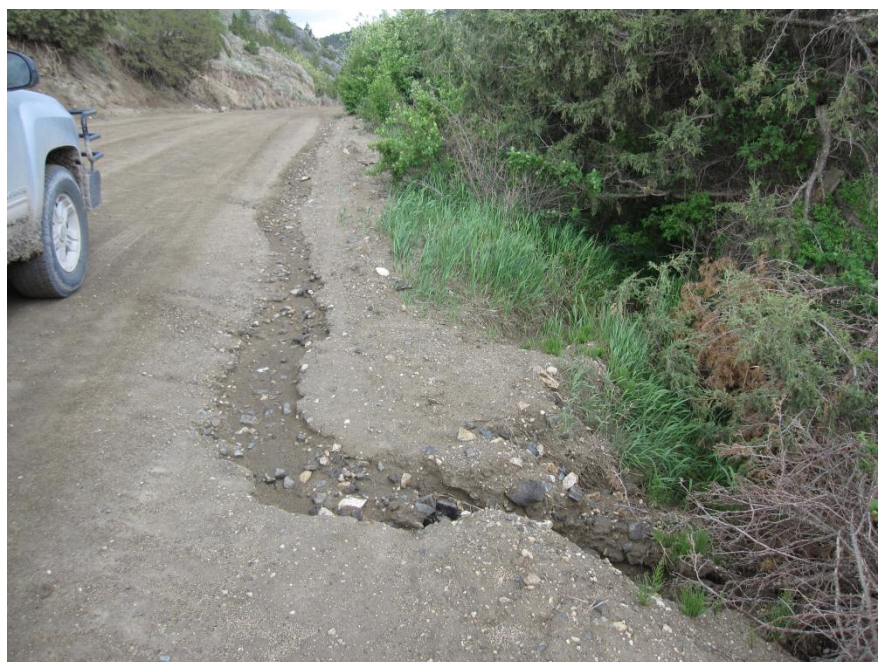
Figure 8. Upper Stone Creek. A storm event erodes the roadway into Stone Creek. (Photo, June 2013)

1. Improve the road grade and install additional sediment traps (**Figure 8**).
2. Work with Beaverhead County and Barrett Minerals to develop a maintenance schedule for cleaning out the sediment traps and re-grading the road.
3. Work with private landowners on grazing management. Install riparian fencing and water gaps (**Figures 9 and 10**).

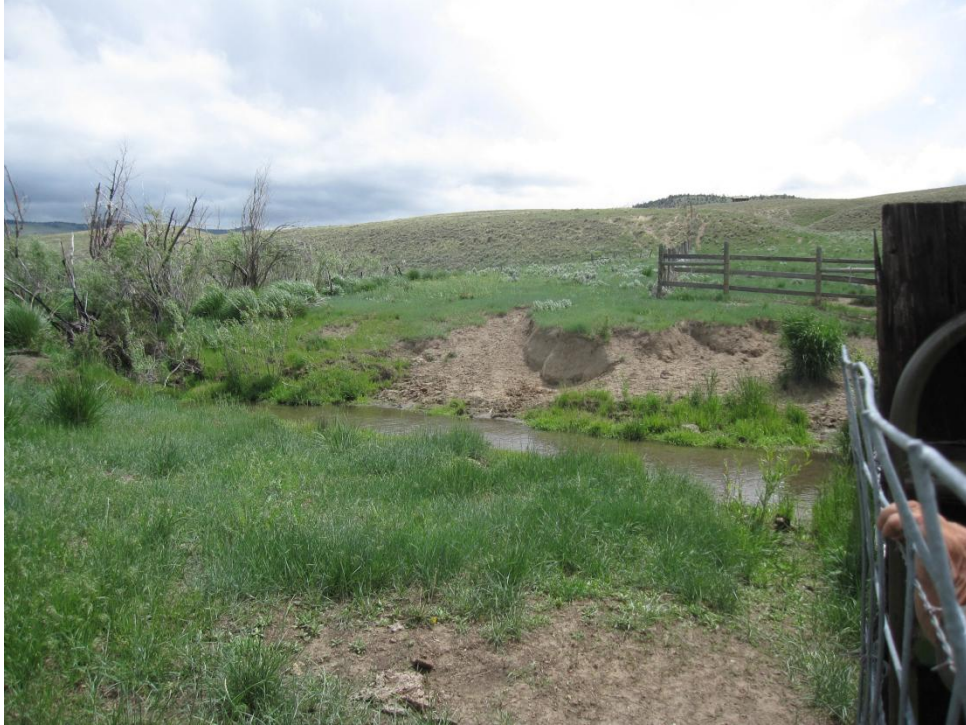
Figure 9. Upper Stone Creek. A water gap is needed to prevent further erosion. (Photo, June 2013)

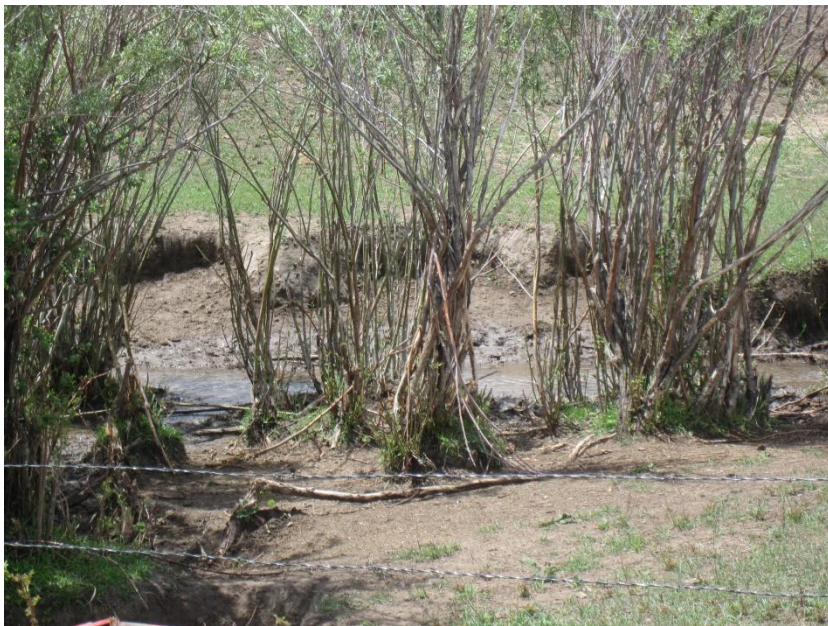
Figure 10. Upper Stone Creek. Riparian fencing is needed to improve riparian vegetation and stabilize bank erosion. (Photo, June 2013)
